# POTASSIUM CORROSION TEST LOOP DEVELOPMENT

Quarterly Progress Report No. 8  
For Quarter Ending July 15, 1965

prepared by  
NATIONAL AERONAUTICS AND SPACE ADMINISTRATION  
Contract NAS 3-2547

SPACE POWER AND PROPULSION SECTION  
MISSILE AND SPACE DIVISION

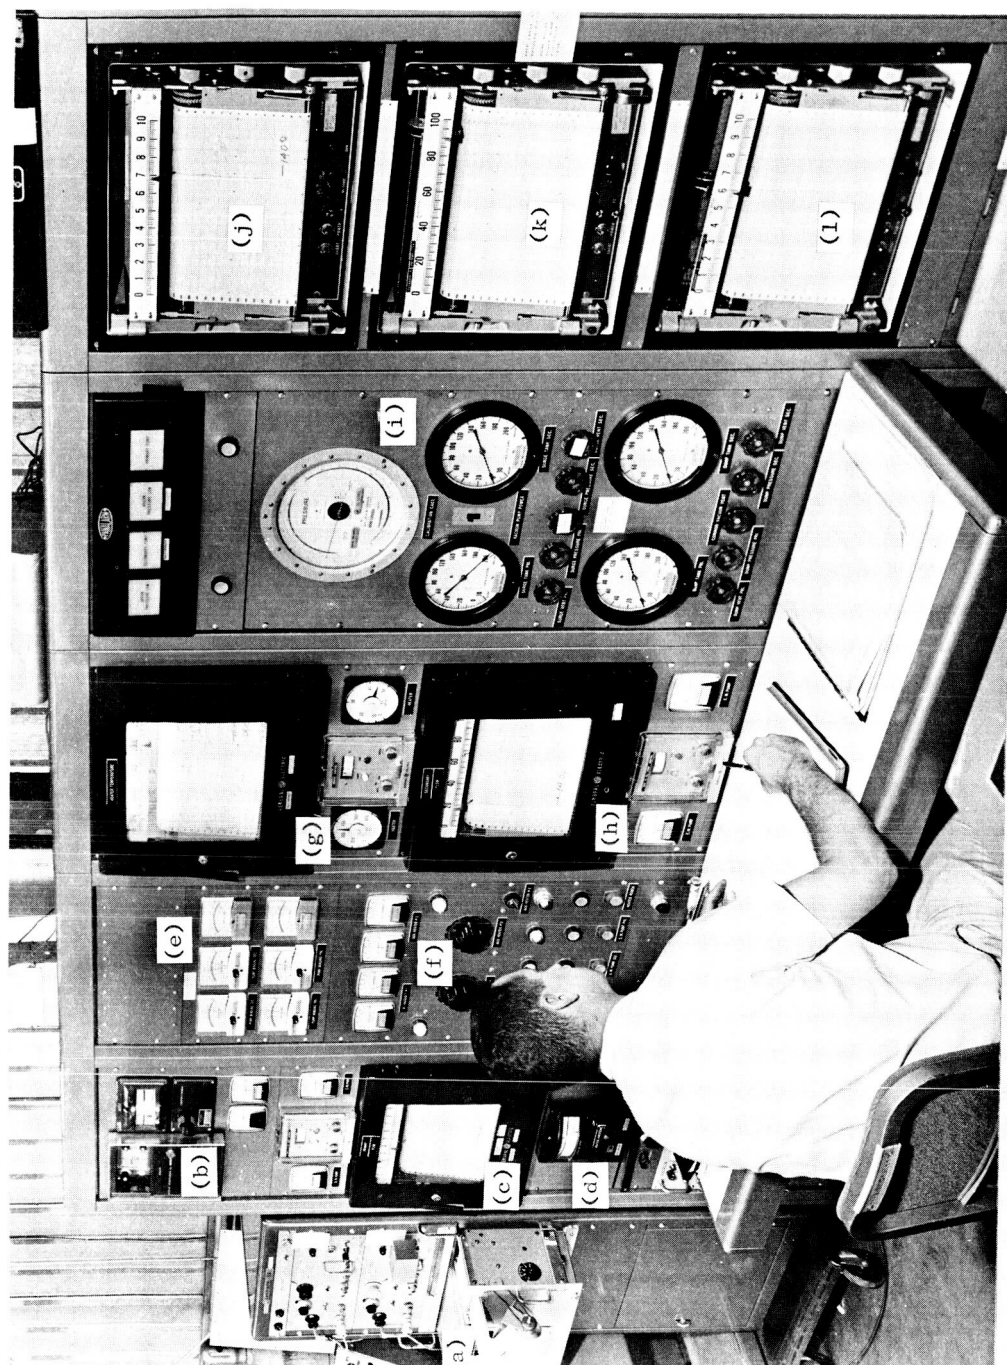
- (a) 2-Channel Sarborn Recorder
- (b) K Preheater Control
- (c) Na Pump Control and Flow Recorder
- (d) Heater Overtemperature Control
- (e) EM Pump Winding Temperatures
- (f) Auxiliary Heater Controls
- (g) Na Heater Control and Recorder
- (h) K Pump Control and Flow Recorder
- (i) Vacuum and Argon Pressure Gauges and Manifold
- (j) K Pressures and Junction Block Temperatures
- (k) Na Circuit Temperatures
- (l) K Circuit Temperatures

Figure 20. Control Console of the Prototype Corrosion Loop. (Orig. C65080601)

The control console, showing most of the instruments used to monitor loop conditions, is shown in Figure 20. The major instruments not shown are the partial pressure gas analyzer, the getter-ion pump console, the two ionization gauge controls, and the four potassium pressure transducer dial indicators.

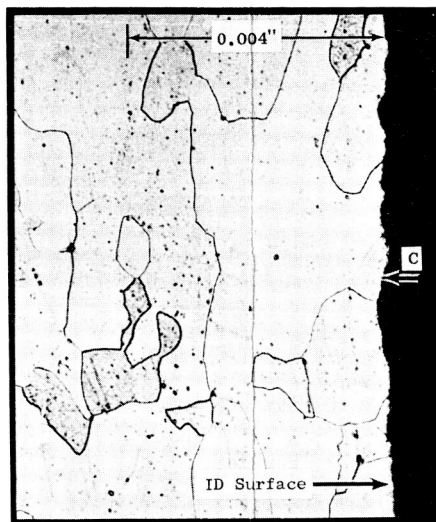
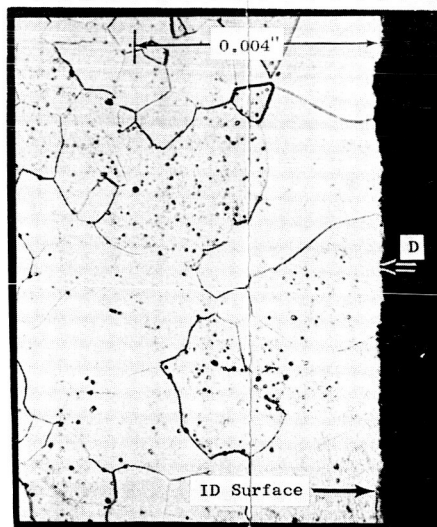
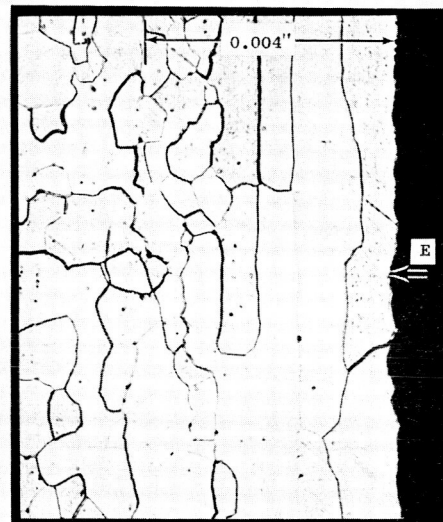
Liquid-Vapor Interface Region

Boiler Region

Sheet Specimen

c) Microstructure of Cb-1Zr Test Components

The metallographic appearance of the surface of the Cb-1Zr capsule in the liquid region and the vapor region above the liquid-vapor interface is shown in Figure 21(c). No corrosion was observed in either these specimens or the sheet specimen which is also shown. A special effort was made to retain any possible surface layers which might be responsible for the dark appearance of the vapor region of the Cb-1Zr alloy capsule. The specimens from this region were nickel plated prior to metallographic preparation to aid in edge preservation. A discontinuous layer with a maximum thickness of 0.1 mil was detected. This layer, which was very fragile, is thought to contain a high concentration of oxygen and may be a complex compound(s) of oxygen, potassium, columbium, and zirconium of the type suggested by the studies of Litman (16).
